Staveley Wastewater Treatment Works

Report on the year-long monitoring of discharges undertaken by Staveley with Ings Parish Council: February 2022 to February 2023

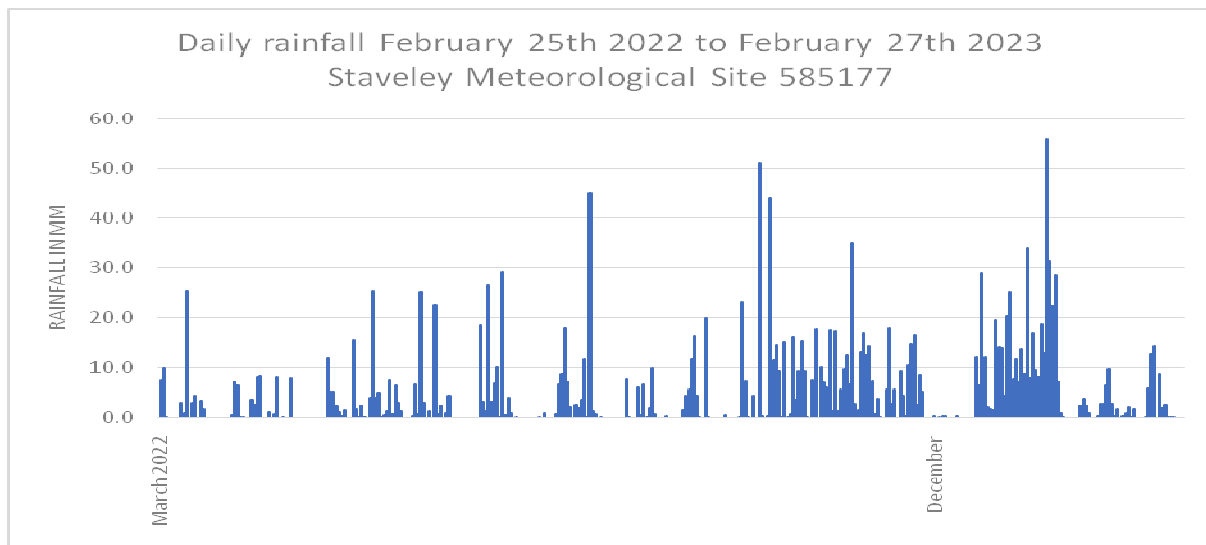
For the observed period the daily rainfall pattern, as recorded at the Meteorological Site 585177 in Staveley, is shown below:

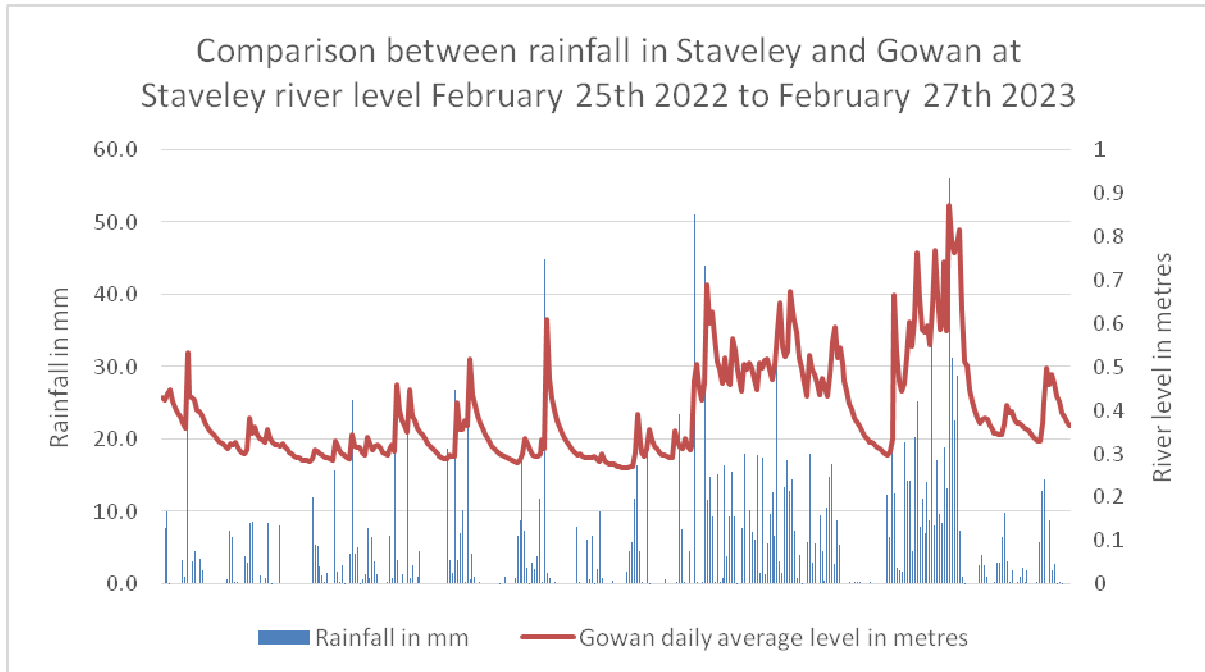
Correlation between rainfall and recorded river level

The following graph shows daily rainfall together with the river levels at the time the Dump Pipe was observed on the 154 observation days when river level data was recorded. There is a broad correlation but some variances. It should be noted that the rainfall data is a record of a 24 hour total whereas the river level data is a single point observation.

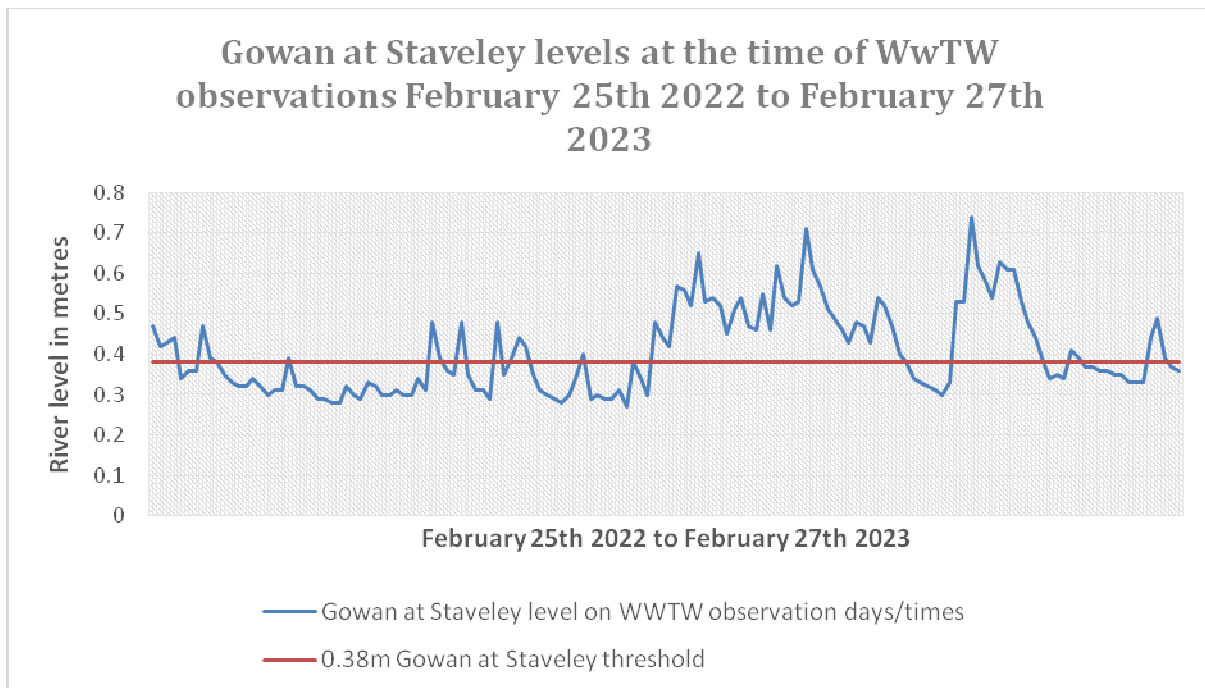
Correlation between river level and Dump pipe discharging

In 90% of the observations the Dump Pipe was discharging once the Gowan at Staveley was 0.38m or above.

- For the Gowan, the best fit threshold level for discharge to occur was shown to be 0.38m. **At or above this level discharge occurred 90% of the time.**

- The lowest (base) level recorded by the Gowan river gauge in Staveley for the whole survey period was 0.27m. **Consequently, a rise of 0.11m (or 11cm) in the level of the Gowan will likely cause discharge from the Dump Pipe at the WwTW.**

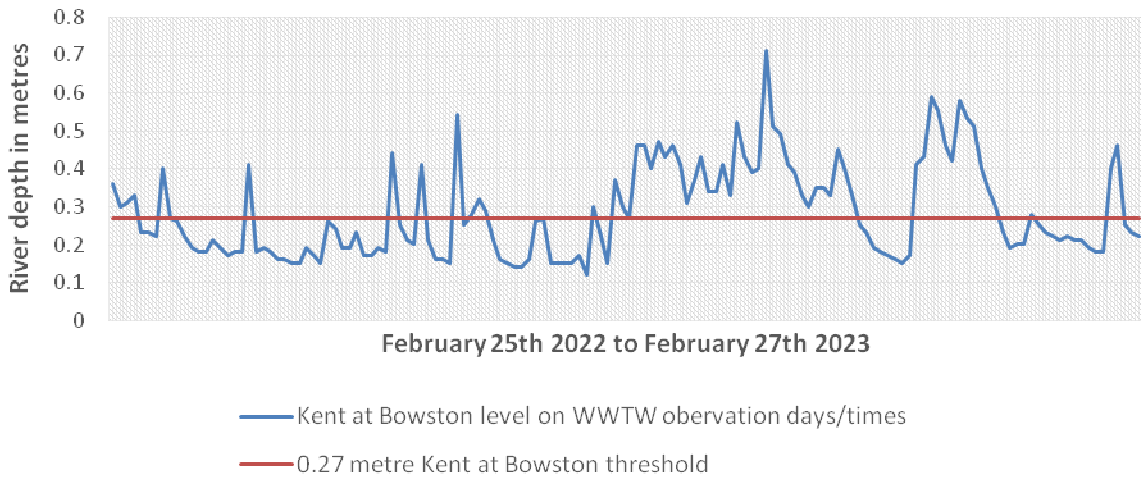
Kent at Bowston levels at the time of WwTW observations February 25th 2022 to February 27th 2023

In 90% of the observations the Dump Pipe was discharging once the Kent at Bowston was 0.27m or above.

- Modelling different threshold values showed that the best fit for the Kent to begin discharging was at a river level of 0.27m. **When the Kent was at or above this level, discharges occurred 90% of the time from the Dump Pipe.**

- The lowest (base) level observed for the Kent during the visits, as recorded at the Bowston measuring station, was 0.12m. **Hence, a rise of just 0.15m (15cm) is 90% certain to result in discharge at the WwTW.**
